TATA Steel - Leeds

NDT Test – Defect Images

Grab Number 1 Serial: 456T, 22 Tonne

Grab Number 2 Serial: 170972, 25 Tonne

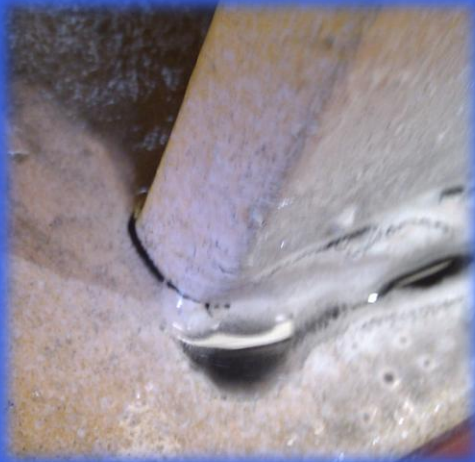
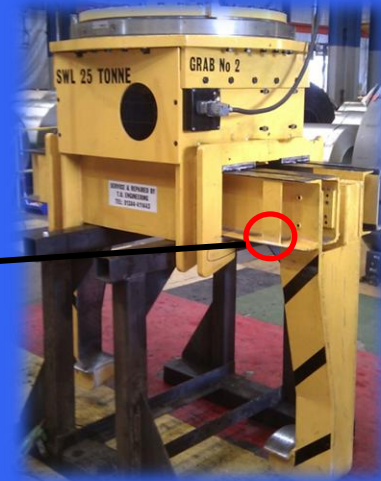
Cracking was found on 19 areas throughout the two 'Coil Grabbers'. All of the surface breaking indications have been circled in black pen and numbered. For specific locations of defects see attached diagrams.

Other smaller cracking was found on all four corner welds of the 8 RSJ runner side plates (see photo).

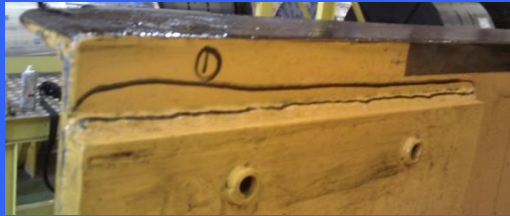
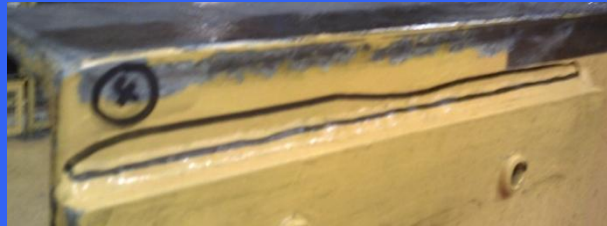
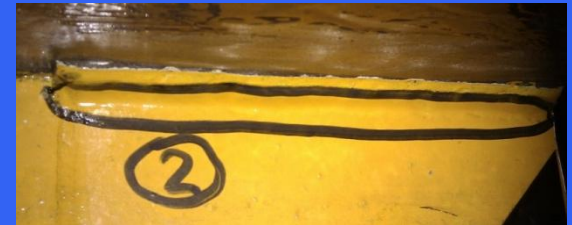
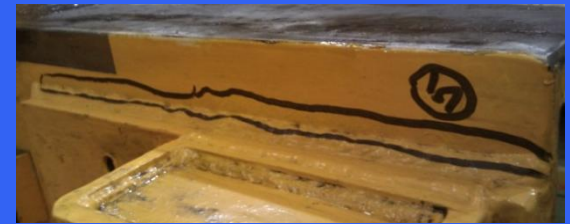
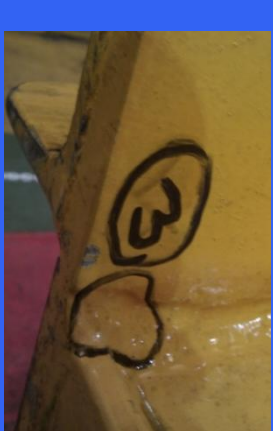
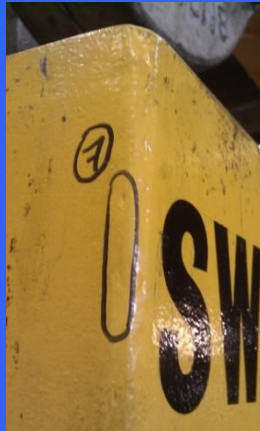
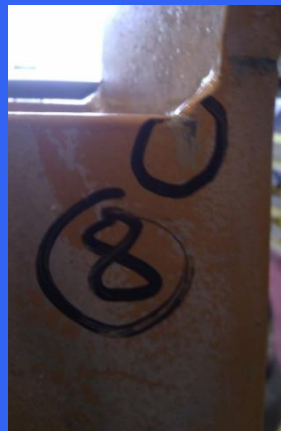
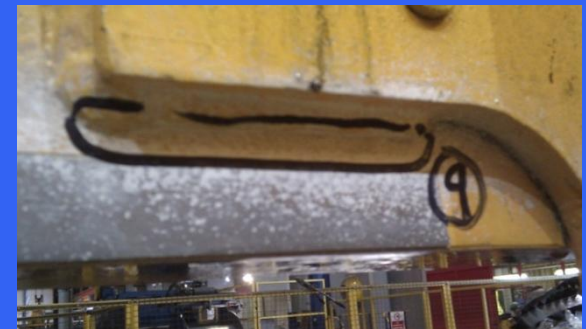
Grab Number 1 Serial: 456T, 22 Tonne

Please note there is no number 6

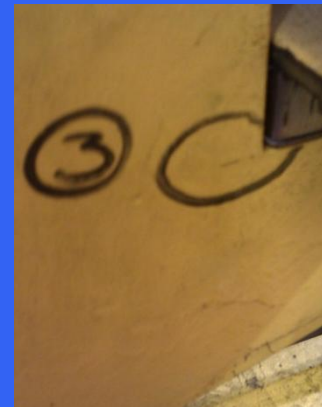
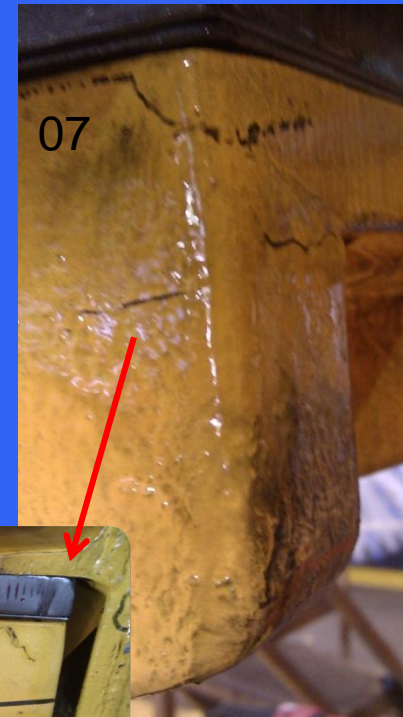
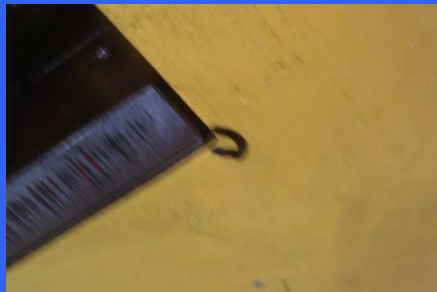
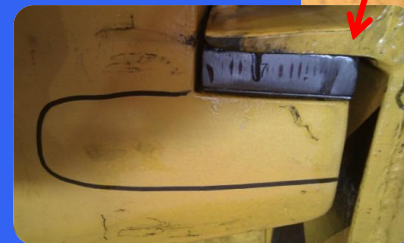
Grab Number 2 Serial: 170972, 25 Tonne

Note: 04 and 06 are the same size and orientation i.e. one photo.

Crack no.07 was intermittent throughout the outlined area.
